# Elevation Changes from Overwash at Ballston Beach, Truro MA: System Evolution and Management Implications

Bryan McCormack, Daniel Genest, Bryan Legare, Theresa Smith,  
Steve Mague, Mark Adams, Mark Borrelli

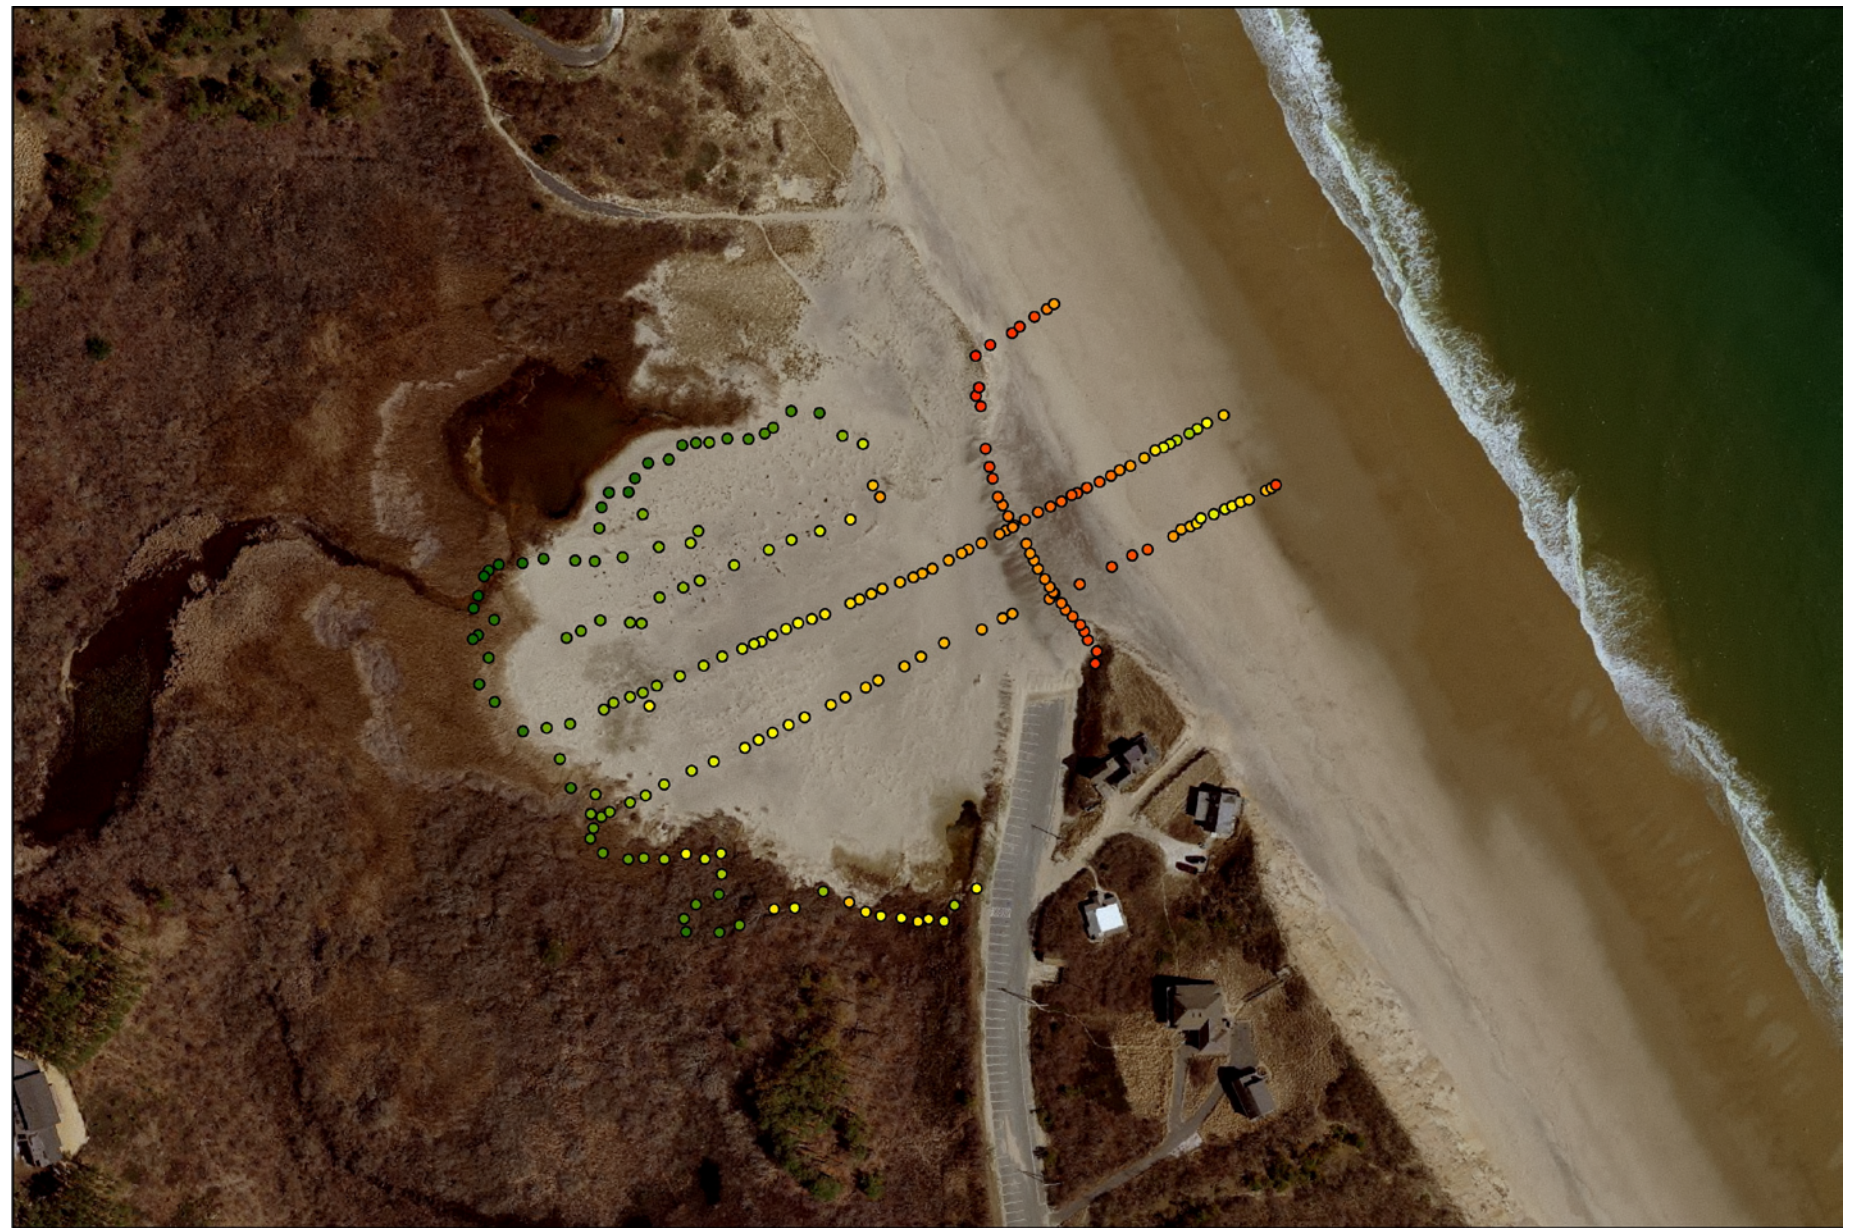
# Typical Survey

Survey Date:  
January 14<sup>th</sup>, 2018

Photo Date:  
April 2013/2014

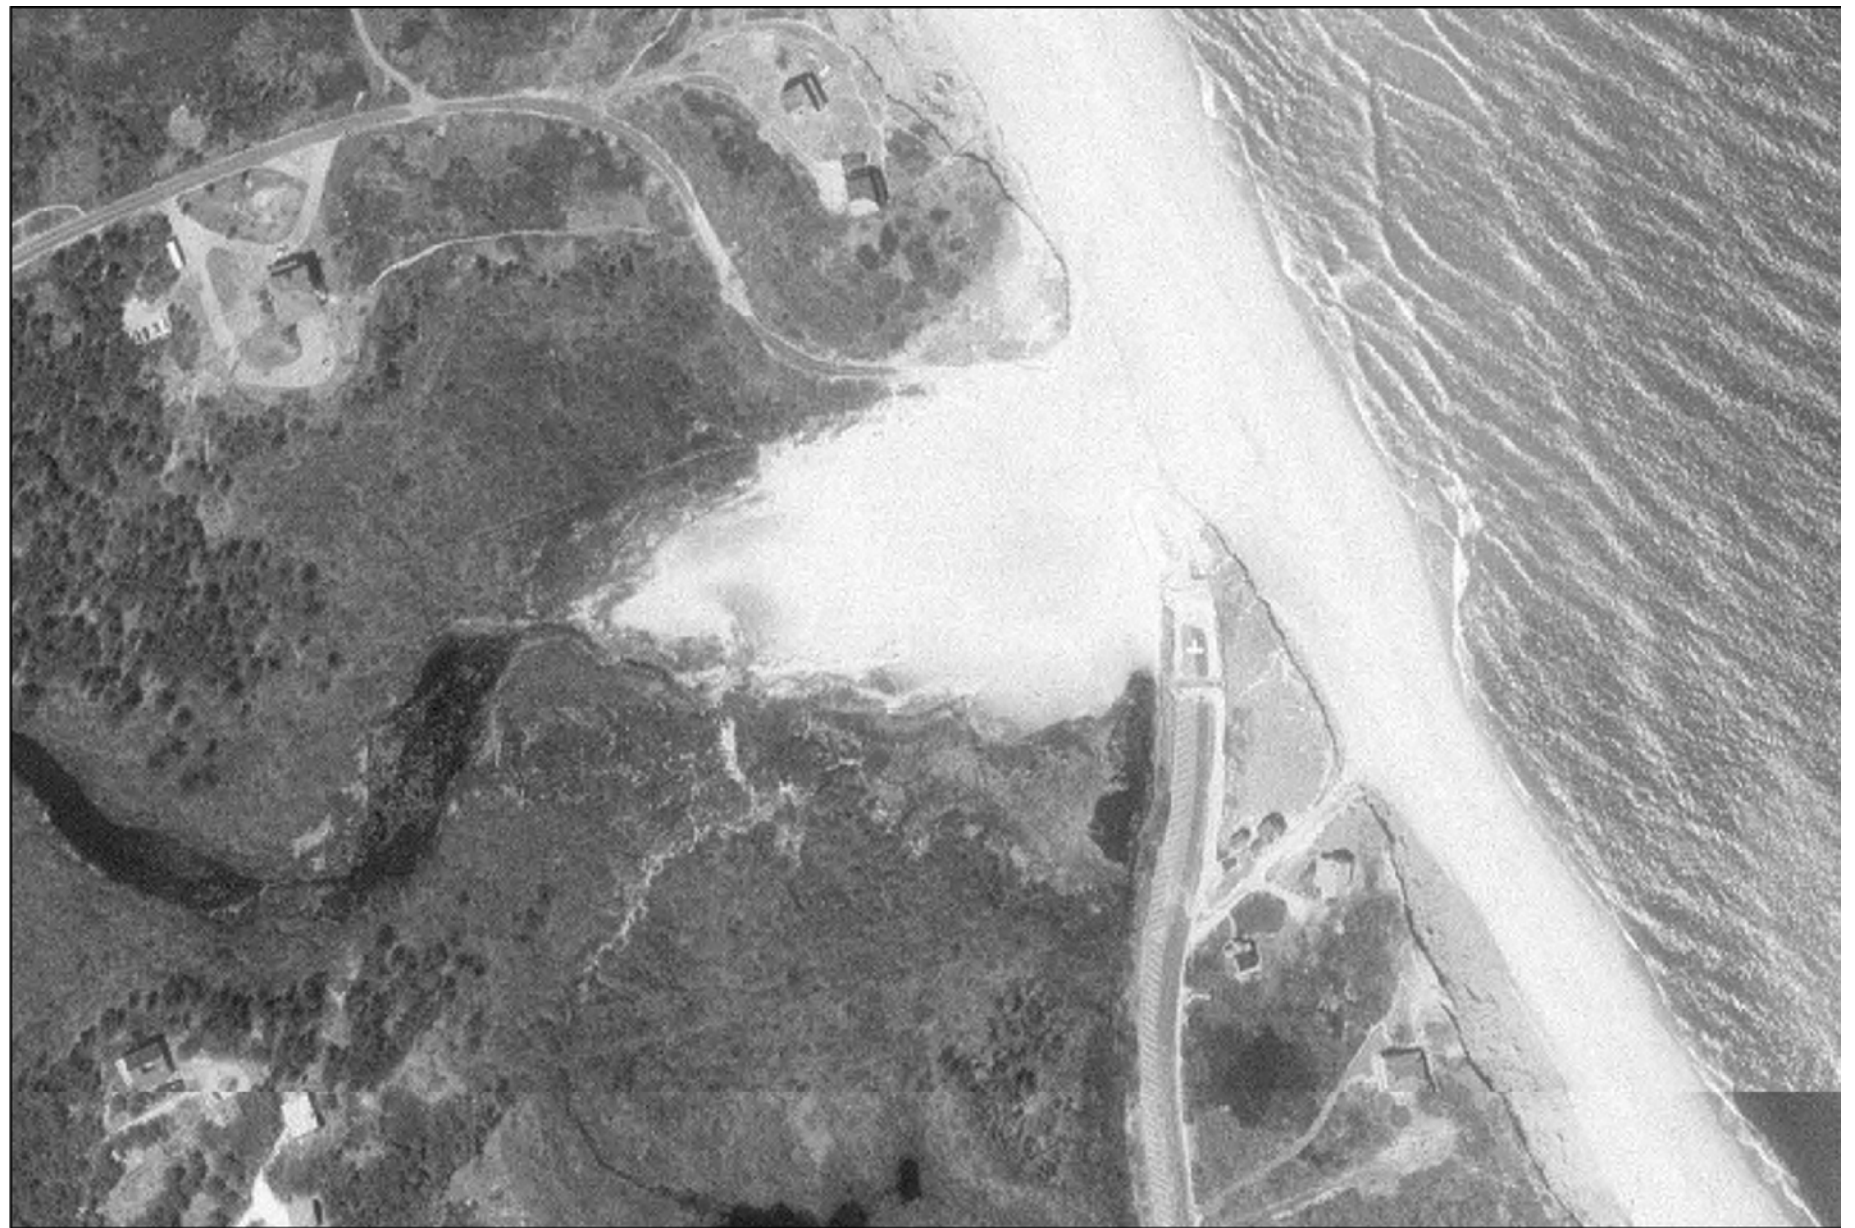
# 1994 Washover Fan Extent

Overwash events:  
October 30<sup>th</sup>, 1991

December 12<sup>th</sup>, 1992

Tide Height (m,  
NAVD88): 2.631,  
2.588 respectively

Photo Date:  
1994

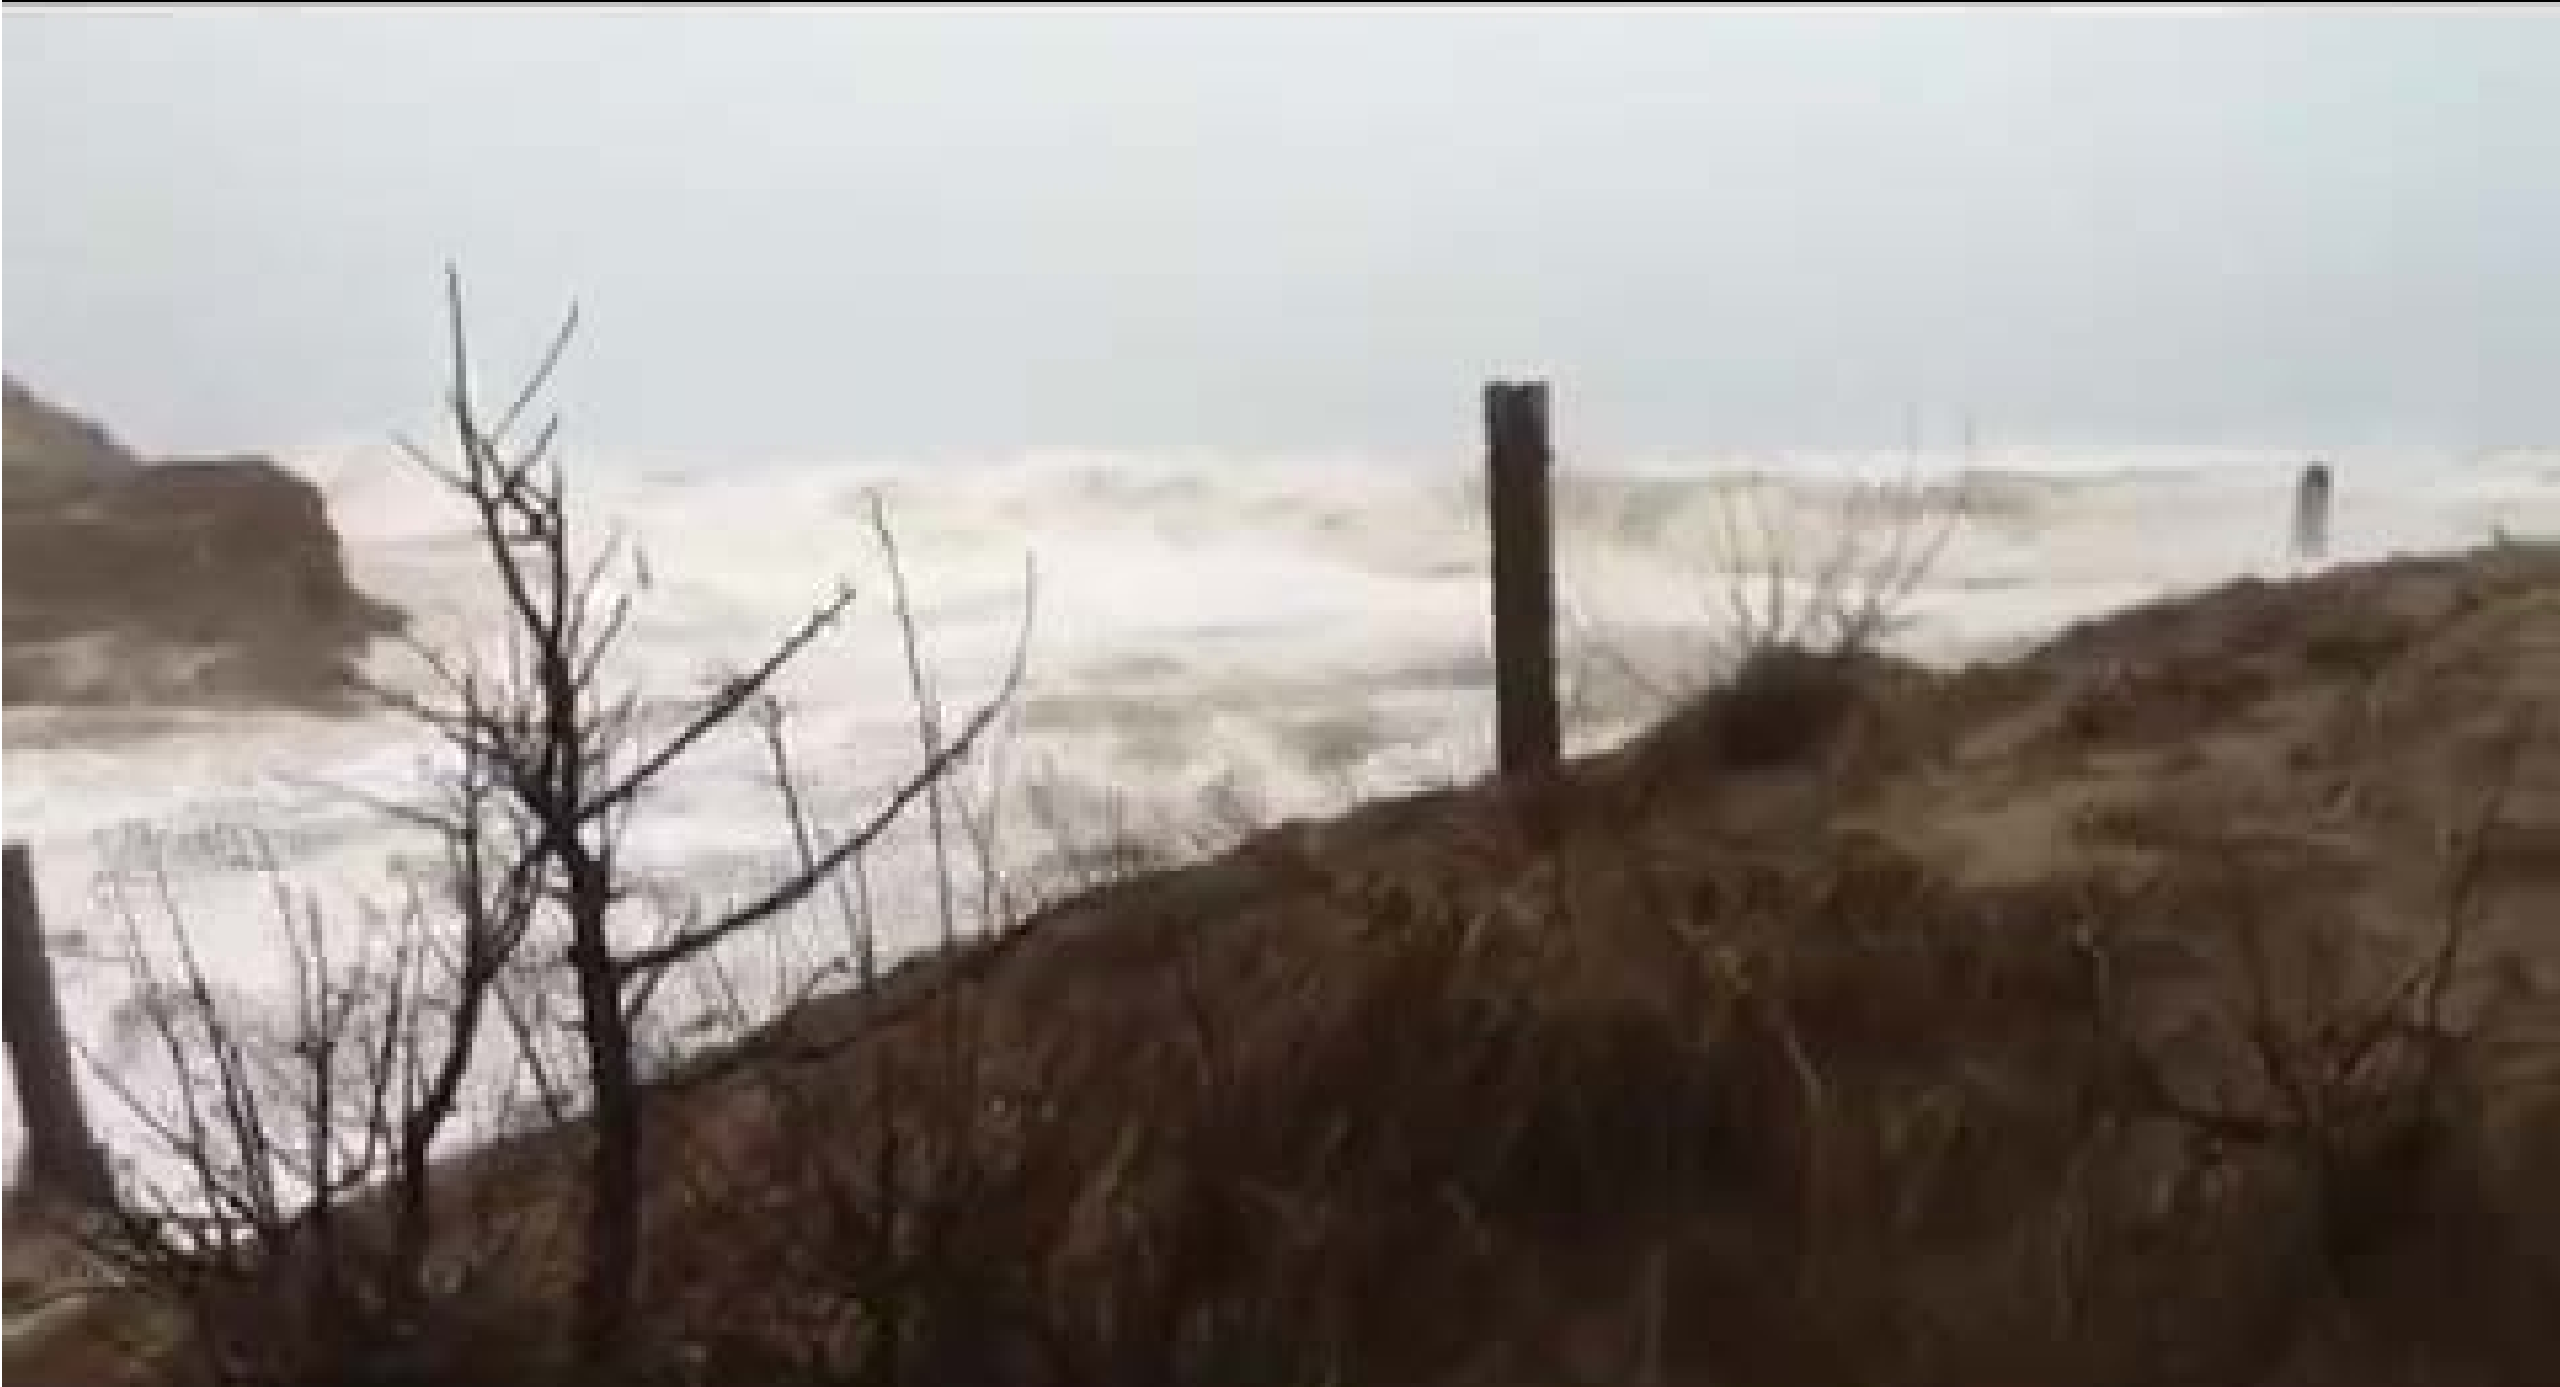
Cape Cod Times (2013, March 8) *Day 2 of the Pamet breach in Truro* [Video File] Retrieved from <https://www.youtube.com/watch?v=j0t3Pdc3MPw>

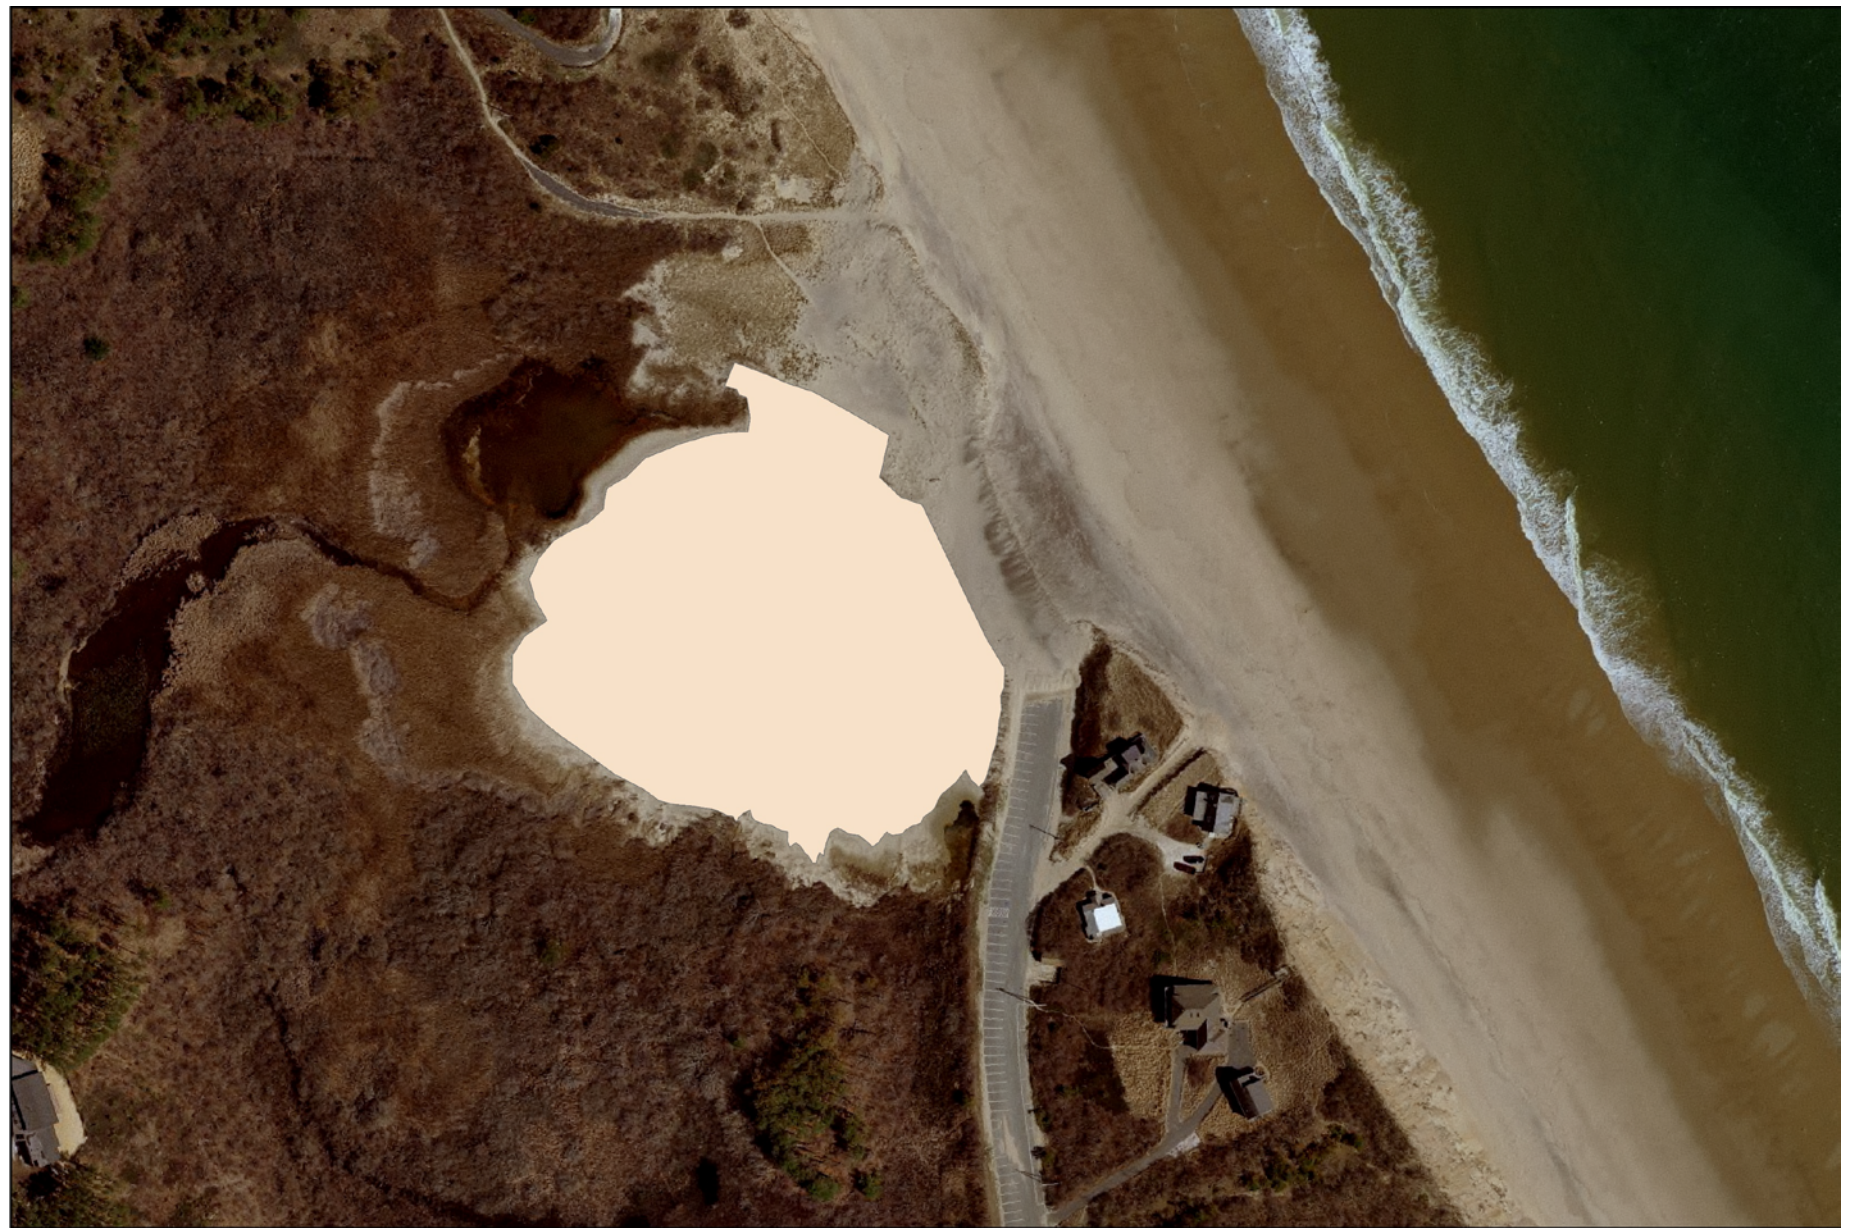
# 2013 Washover Fan Extent

Overwash Event:  
March 8<sup>th</sup>, 2013

Tide Height (m,  
NAVD88): 2.253

Survey Date:  
July 25<sup>th</sup>, 2013

Photo Date:  
April 2013/2014

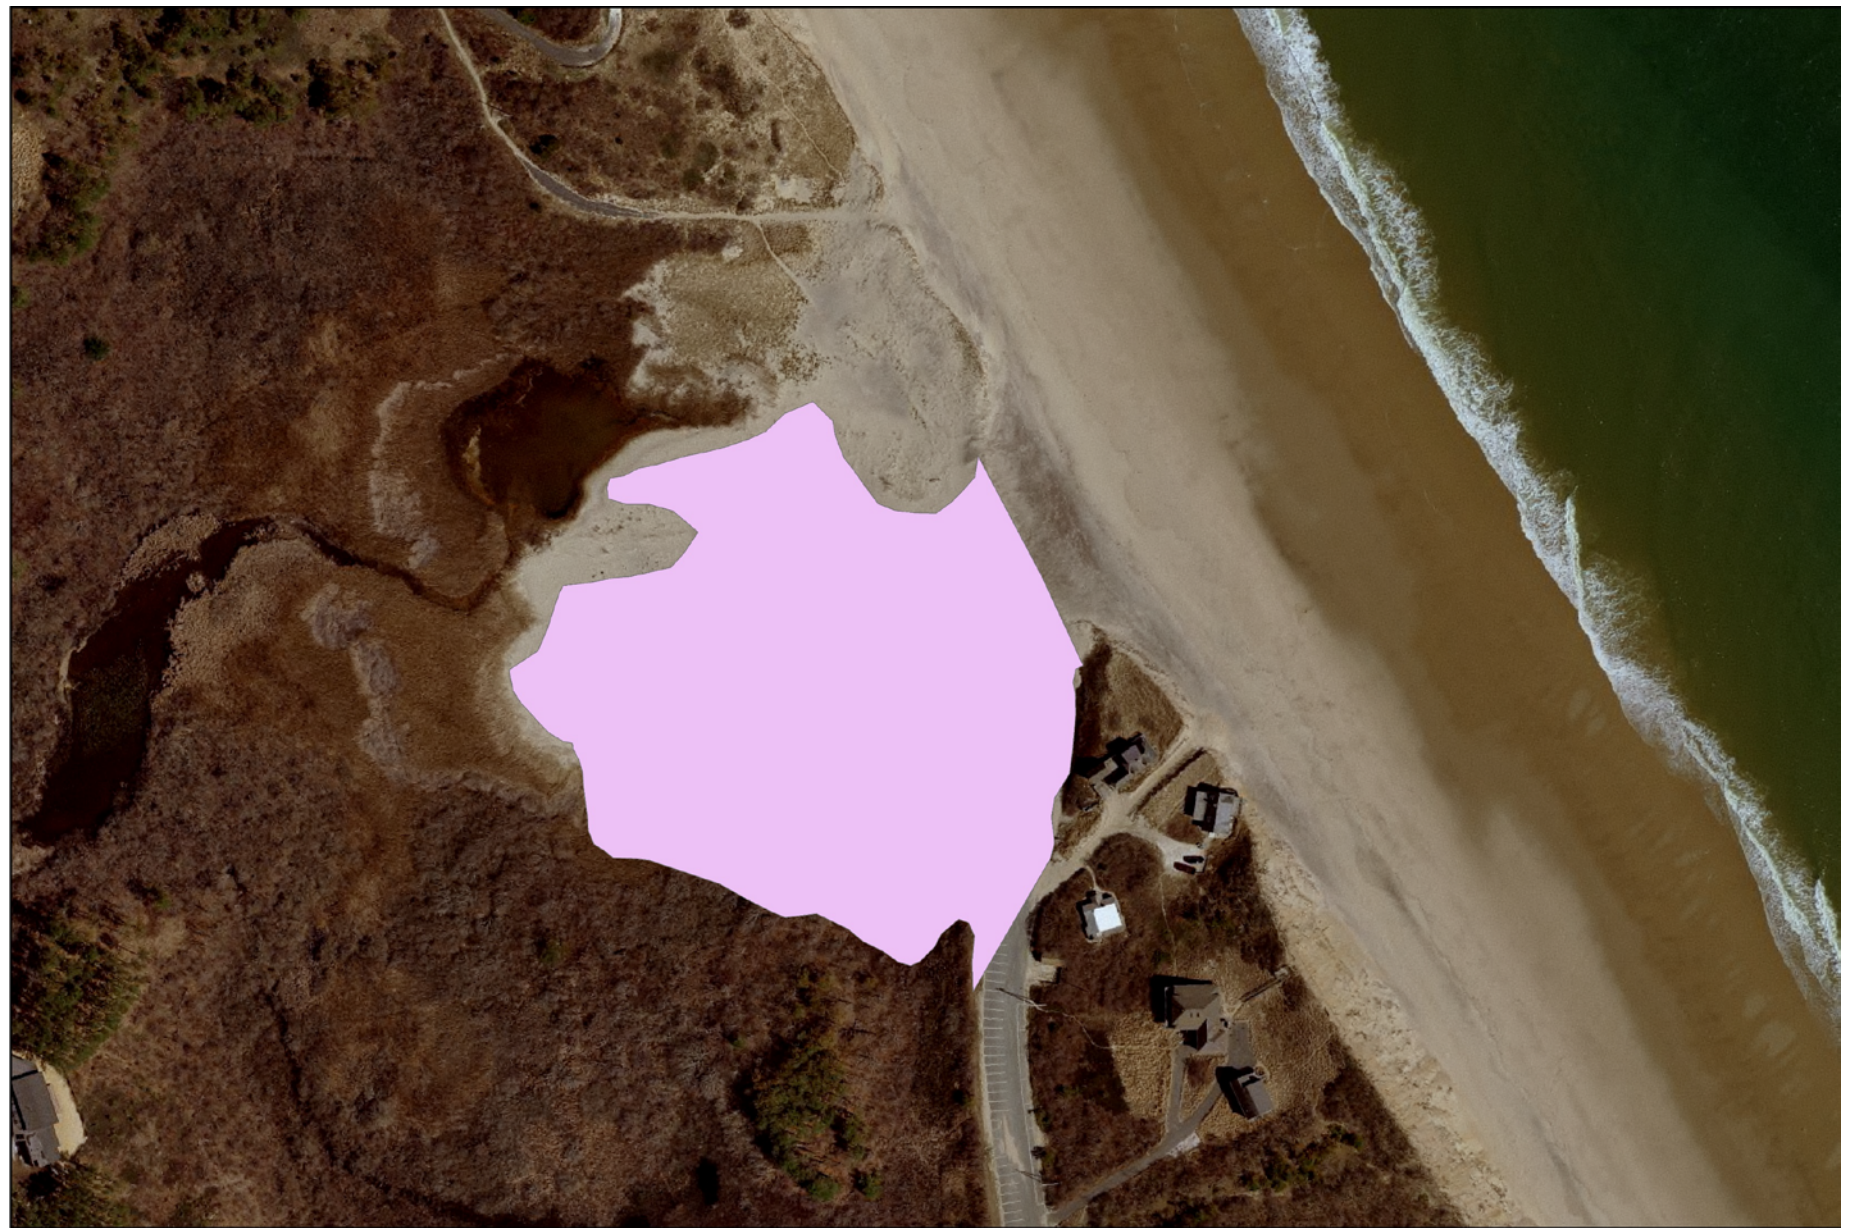
# 2015 Washover Fan Extent

Overwash Events:

January 27<sup>th</sup>, 2015

February 15<sup>th</sup>, 2015

Tide Height (m,  
NAVD88): 2.477,  
2.016 respectively

Survey Date:

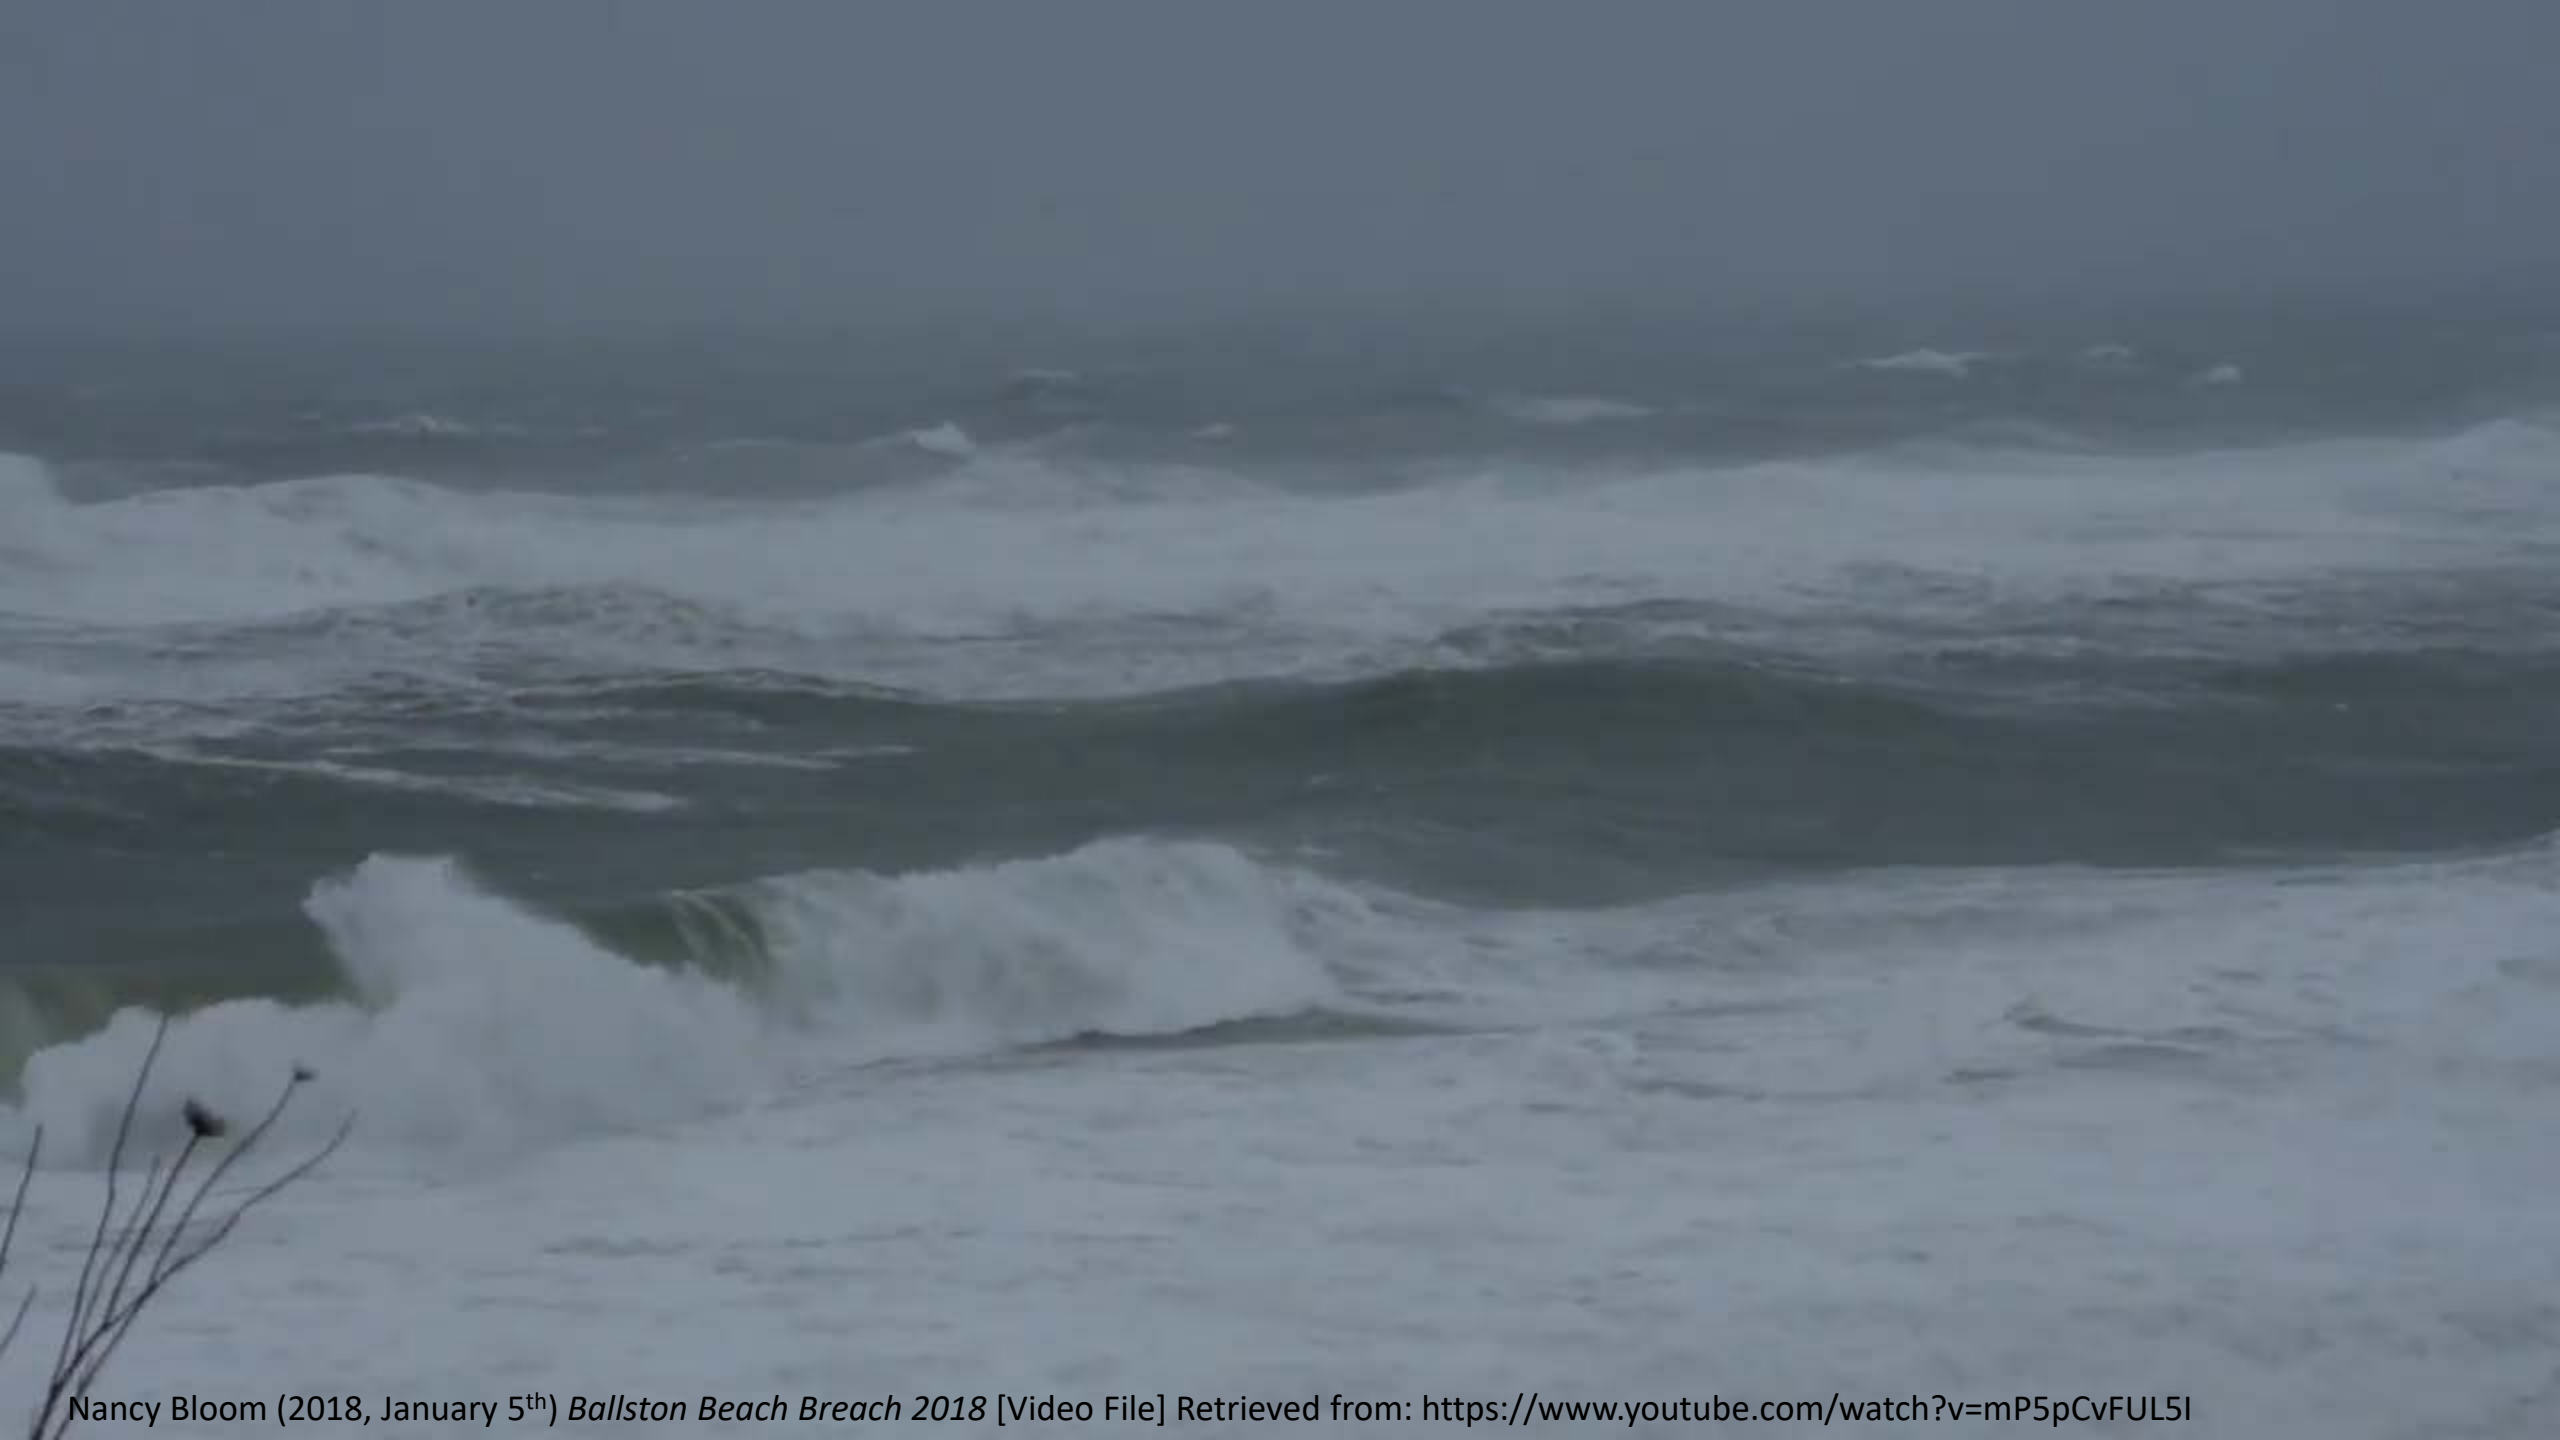
# January 2018

December 17<sup>th</sup>, 2017  
January 14<sup>th</sup>, 2018

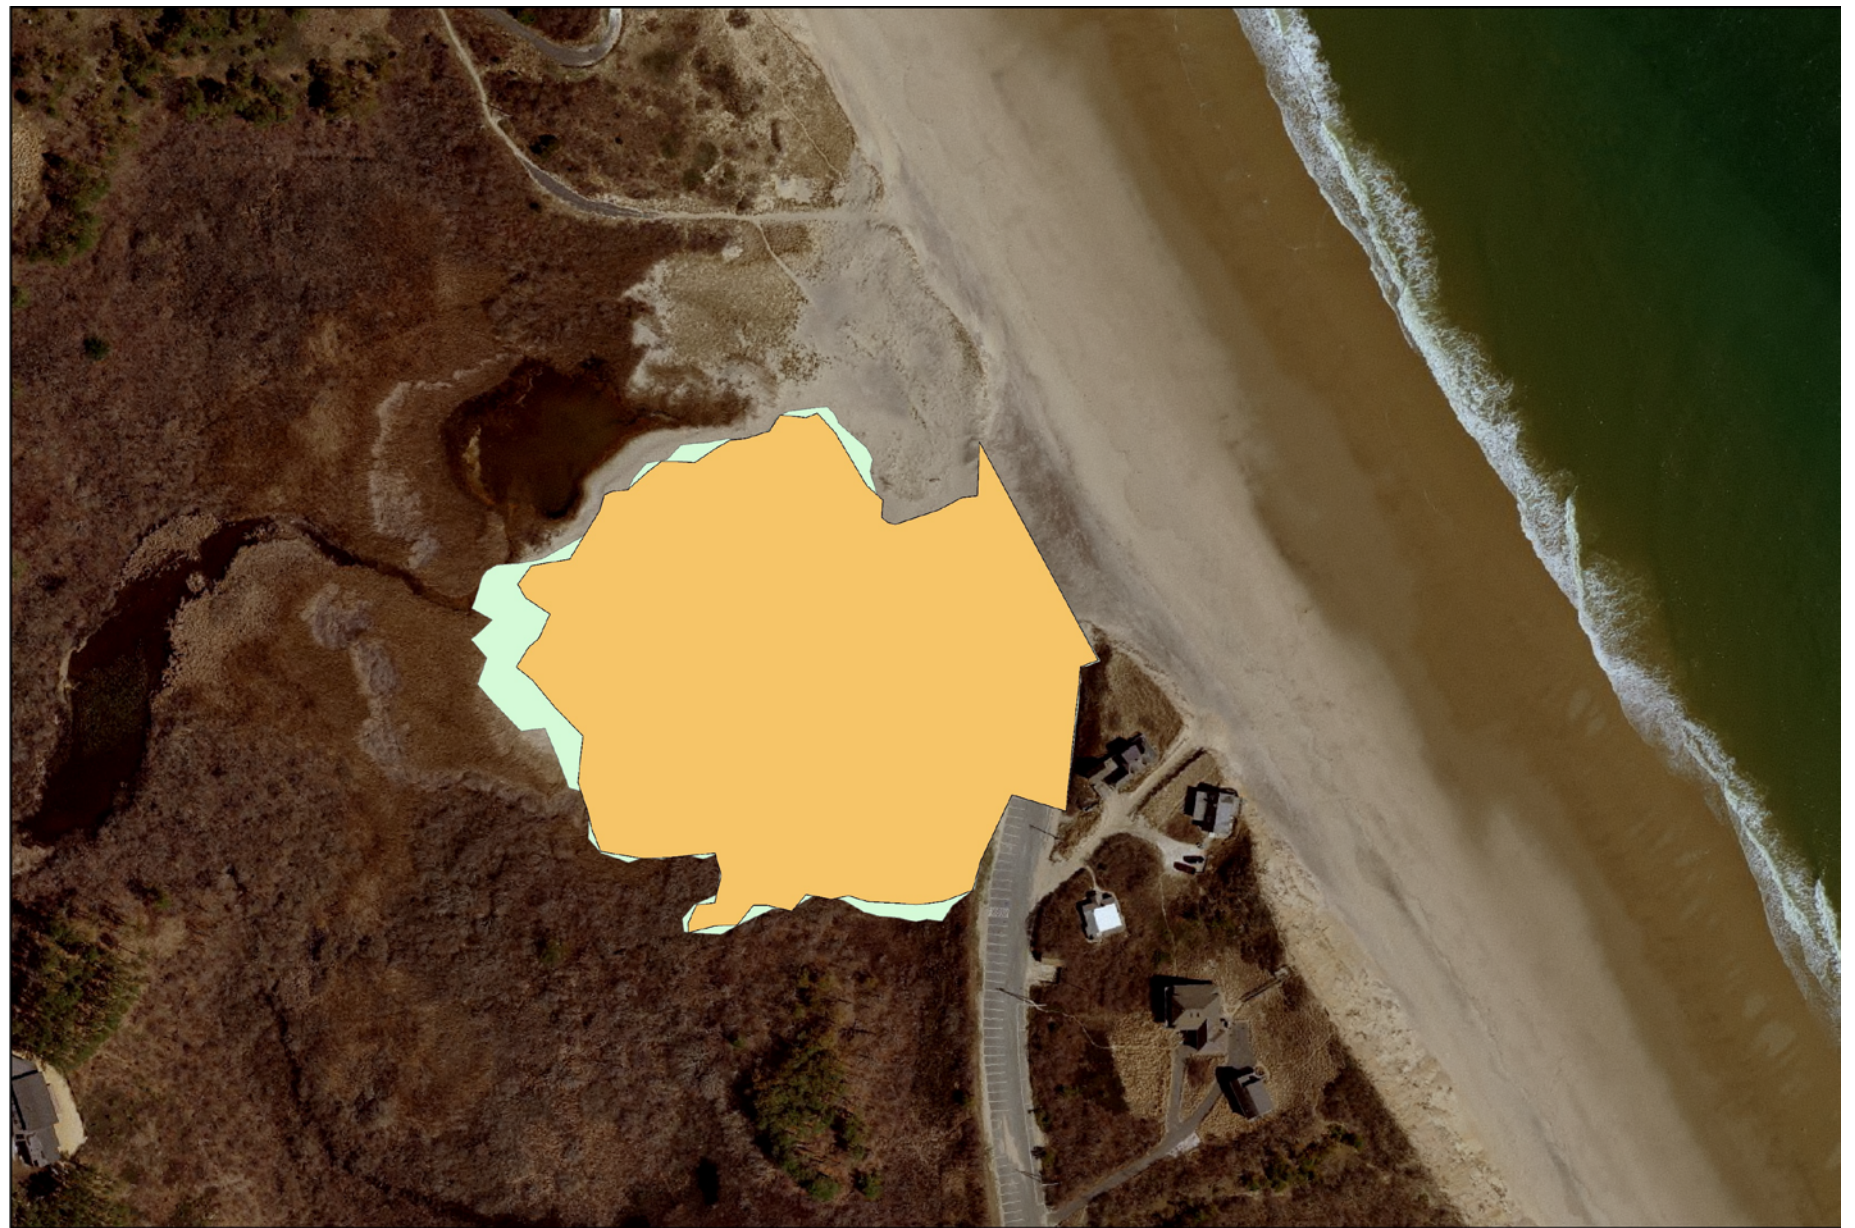
# 2018 Washover Fan Extent

Pre- vs. post-  
January 4<sup>th</sup>, 2018  
storm
